febi 22350

Mercedes-Benz Trucks Actros I, Actros II & III,
Arocs, Axor I & II
Repl. no. 948 350 30 05

V-Stay

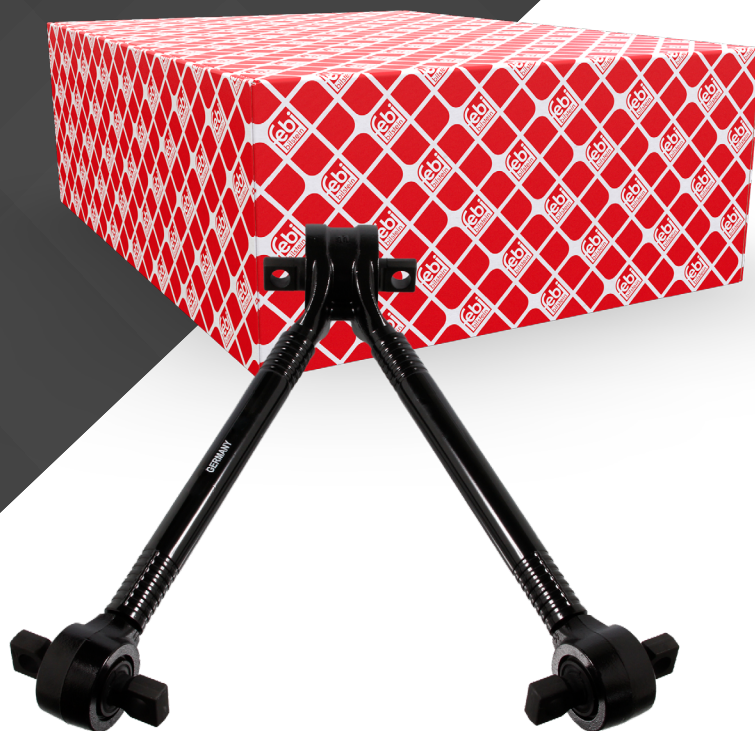
Premature wear of the V-stay central bearings.

The rivets holding the V-stay mounting brackets to the chassis can be subject to excessive stress if the vehicle is overloaded or the vehicle is travelling on bad road surfaces. Play maybe experienced at the bearing mounting brackets caused by wear on the retaining rivets or the rivets missing completely. Even a minimum amount of play will cause central bearing to fail due to the additional stress being transferred.

Before repairing or fitting a new febi 22350 V-stay, check for missing or loose rivets and replace as required. If rivets are missing, they can be replaced with suitable bolts. febi recommend that 26709/26710 thread lock is used to prevent the bolts from becoming loose.
