The Missing Link

In this article we investigate an example fitted to a BMW E61 520d, that had covered 180,000km and had an engine that suddenly stopped, due to a suspected timing chain failure.

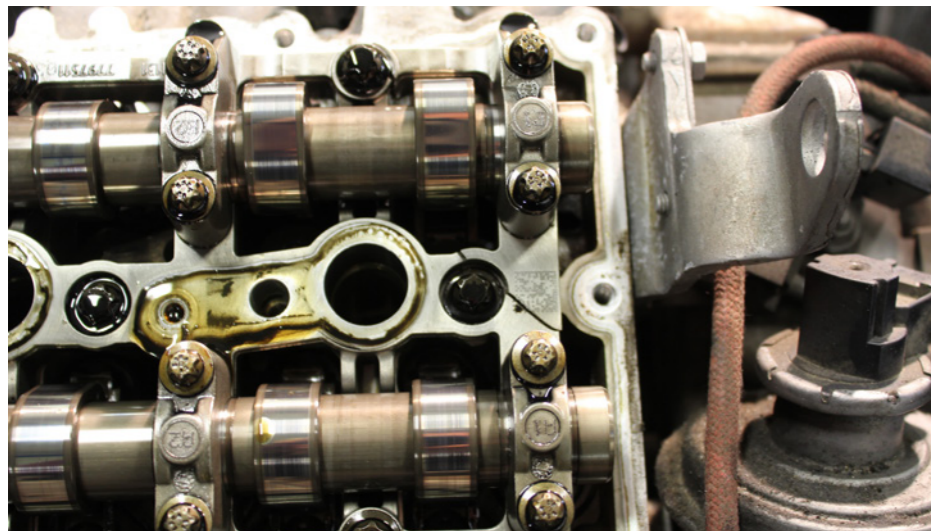
afb. 1

With the engine removed, the rockercover was taken off to view any damage. The camshaft chain was not visible and after inspection it was located at the bottom of the timing chain housing and also five rocker arms were broken.

The camshaft support had sustained a significant fracture, which shows that a significant torsional force has been absorbed by the engine timing components. (Fig 1)

The cylinder head was prepared for reassembly with a new camshaft support, camshaft and new rocker arms (febi 30132). Note: the tightening of the bracket bolts must not exceed 20Nm and it is important to ensure that the camshaft bearings are lubricated before installation.

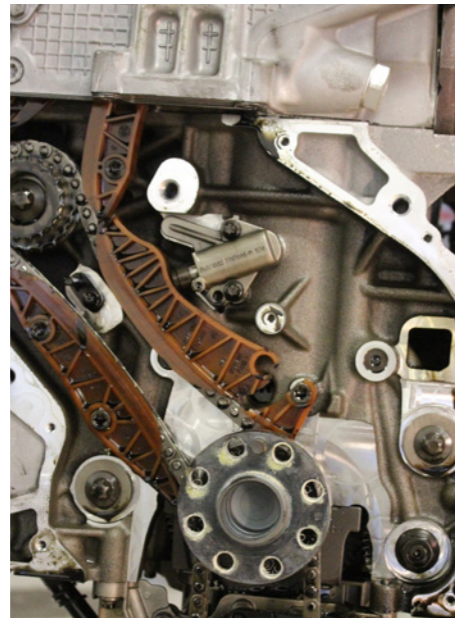
afb. 2

After the removal of the timing chain housing, further damage was revealed. The upper chain had one broken link, the high-pressure fuel pump sprocket had broken teeth and the chain guide was also broken. (Fig 2)

This is a typical example of a chain failure on the N47 engine.

The febi timing chain kit 102040 for this engine has all the necessary parts for the repair. The kit includes upper and lower chains, chain guides, tensioners and sprockets for the fuel injection pump and camshafts and also the oil nozzle for the lower chain.

This kit corresponds to the latest technical developments necessary to prevent the chain from breaking again. It has an upgraded version of the chain guides and superior quality chains treated with a TRITAN® coating. This coating improves friction properties to reduce wear and optimizes engine fuel consumption.

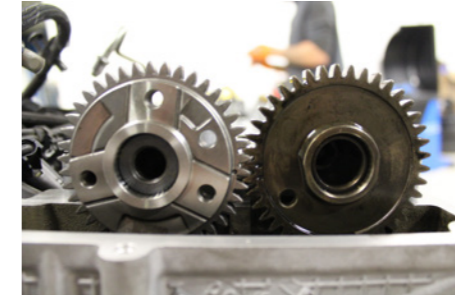
afb. 3

Then the timing of the camshafts and crankshaft was checked, this is essential for correct engine operation. The camshaft

pinions have timing marks, which must be placed opposite each other parallel to the cylinder head. (Fig 3) The crankshaft is fixed by means of a pin in the flywheel, which is removed, we recommend that it be temporarily reassembled to check the locking.

With all chains in place and the flywheel locked in position, the alignment was checked of the AAC markings on the cylinder head. As everything was correct, the camshaft sprocket was tightened with the three retaining bolts. If the alignment is not correct it can be corrected by turning the exhaust camshaft with a 32 mm spanner. Then check the fuel injection pump sprocket for the correct tightness.

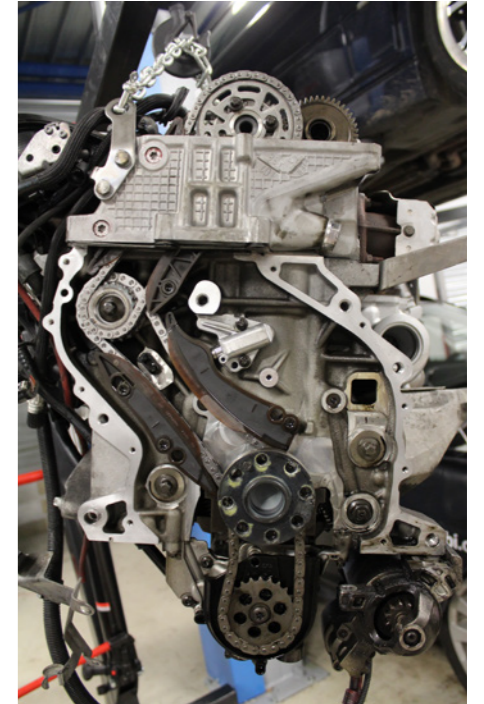
afb. 4

The assembly of the febi 102040 timing chain kit was complete, the engine was turned over by hand for several revolutions to check that the engine was turning freely. (Fig 4)
